**Flood Control Project Maintenance
Levee Inspections**
LMA District Cover Sheet
Spring 2019 Levee Inspection Results

Yolo County Service Area 6

Spring 2019 Levee Inspection Results

Waterway			Bank	Unit Miles
Unit No. 01 Right Bank of Sacramento River at Knights Landing			Right	5.87
	Spring (March - May)	Summer (June - August)	(September - November) Fall	Winter (December - February)
Unit Maintenance Rating (Fall Only)				
Date of Inspection	3/29/2019 - 3/29/2019			
DWR Inspector	Zach Jojola			
Accompanied By	Casey Leibler Yolo County			
	Thomas Engler MBK

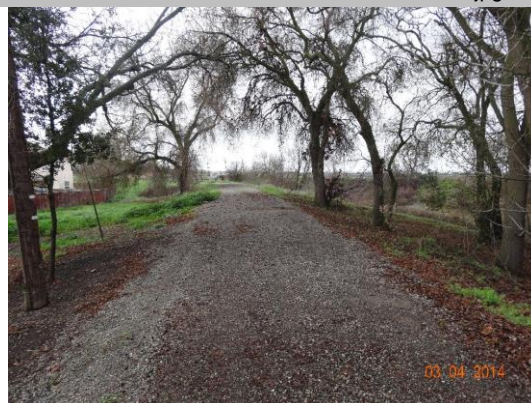
Photo 2 of 3 : UCIP_SP_2019_31903_58221.jpg

Comment Code						
Inspector Comment						
FS_ID:31903						
DS_ID:19515						
EP_NO: 9425						
Repair Type: Non-Urgent						
Crossing Status: Found						
UCIP Comments: Need to properly abandon crossing per Title 23-- pipe has been disconnected. No signs of pipe visible on waterward and landward sides. Need to contact owner to determine additional information about pipe section through levee.						
FIELD_STRUCT_DESC: *ABANDONED* 8-inch steel irrigation discharge pipe through the levee, 3 feet below the crown. Pump structure in the channel. 8-inch pipe replaced by a 4-inch pipe. (Retention of an 8-inch steel pipe through the levee and a pump on a platform on the waterside [WS] authorized under Automatic Board Order (ABO) issued as Permit No. 9425, 1974 - Albert E. Nuttall). [Additional Reference(s): DWR Levee Log, 2005].						
FS Date: 3/4/2014

Overview of levee crown looking at crossing.

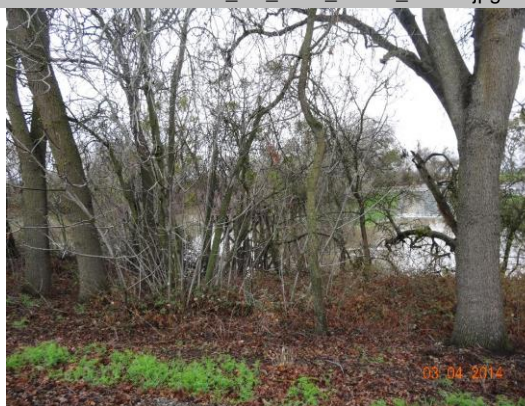
Photo 3 of 3 : UCIP_SP_2019_31903_58220.jpg

Comment Code						
Inspector Comment						
FS_ID:31903 DS_ID:19515 EP_NO: 9425 Repair Type: Non-Urgent Crossing Status: Found UCIP Comments: Need to properly abandon crossing per Title 23-- pipe has been disconnected. No signs of pipe visible on waterward and landward sides. Need to contact owner to determine additional information about pipe section through levee. FIELD_STRUCT_DESC: *ABANDONED* 8-inch steel irrigation discharge pipe through the levee, 3 feet below the crown. Pump structure in the channel. 8-inch pipe replaced by a 4-inch pipe. (Retention of an 8-inch steel pipe through the levee and a pump on a platform on the waterside [WS] authorized under Automatic Board Order (ABO) issued as Permit No. 9425, 1974 - Albert E. Nuttall). [Additional Reference(s): DWR Levee Log, 2005]. FS Date: 3/4/2014

View of waterward side.

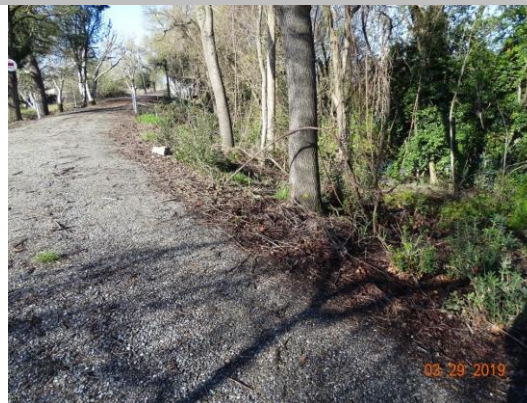
Photo 1 of 1 : SP_2019_NA0022_350_43_20190329_00128.jpg

LM Start	0.15	Rating **	C	Issue No.	49
LM End	0.15	Issue Type +	Ma	Location *	WS
Category	Earthen Levee			GPS Latitude/Longitude	
				Start	End
Item	Encroachments			38.800842 °	38.800842 °
				-121.722777 °	-121.722777 °
DWR ID	DWR_NA0022_01_f_2018_49				
Comment Code					
TR : Tree or limb					
Inspector Comment

View of vegetation on the waterside slope. Spring 2019.

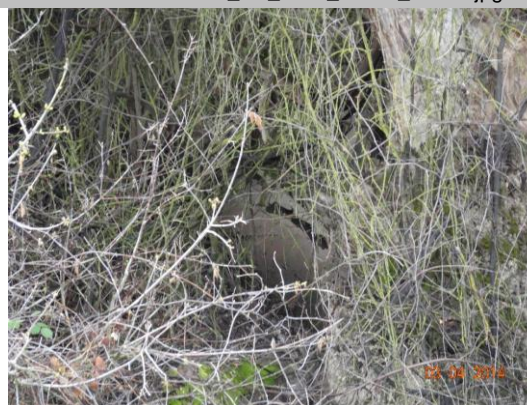
Photo 1 of 3 : UCIP_SP_2019_31904_58228.jpg

LM Start	0.21	Rating **	M	Issue No.	397
LM End	0.21	Issue Type +	En	Location *	
Category	Supplemental			GPS Latitude/Longitude	
				Start	End
Item	DWR UCIP Field Study			38.801280 °	38.801280 °
				-121.722000 °	-121.722000 °
DWR ID	19516				
Comment Code					
Inspector Comment					
FS_ID:31904 DS_ID:19516 EP_NO: N/A Repair Type: Non-Urgent Crossing Status: Indicator Found UCIP Comments: Need to properly abandon per Title 23 if corssing is no longer used--debris inside concrete box and near site. Need to contact owner. FIELD_STRUCT_DESC: 48-inch corrugated metal gravity drainage pipe through the levee, 14.5 feet below the crown. Slide gate in a concrete box on the waterside (WS) bank. (Automatic Board Order (ABO) issued as Permit No. Unknown, 1976 - Wallace) [Additional Reference(s): DWR Levee Log, 2005]. FS Date: 3/4/2014

Pipe section with holes abandoned on waterward side.

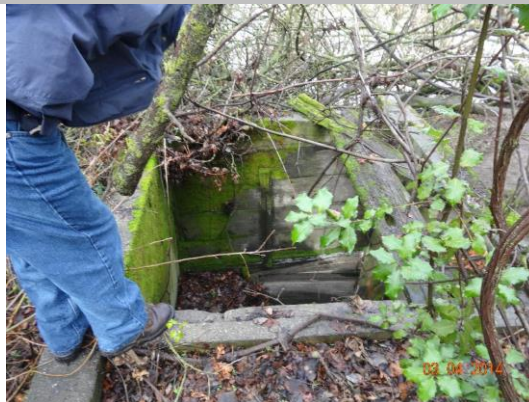
Photo 3 of 3 : UCIP_SP_2019_31904_58226.jpg

LM Start	0.21	Rating **	M	Issue No.	397 (cont)	
LM End	0.21	Issue Type +	En	Location *		
Category	Supplemental			GPS Latitude/Longitude		
				Start		End
Item	DWR UCIP Field Study			38.801280 °		38.801280 °
				-121.722000 °		-121.722000 °
DWR ID	19516					
Comment Code						
Inspector Comment						
FS_ID:31904 DS_ID:19516 EP_NO: N/A Repair Type: Non-Urgent Crossing Status: Indicator Found UCIP Comments: Need to properly abandon per Title 23 if corssing is no longer used--debris inside concrete box and near site. Need to contact owner. FIELD_STRUCT_DESC: 48-inch corrugated metal gravity drainage pipe through the levee, 14.5 feet below the crown. Slide gate in a concrete box on the waterside (WS) bank. (Automatic Board Order (ABO) issued as Permit No. Unknown, 1976 - Wallace) [Additional Reference(s): DWR Levee Log, 2005]. FS Date: 3/4/2014

Concrete box located on waterward side.

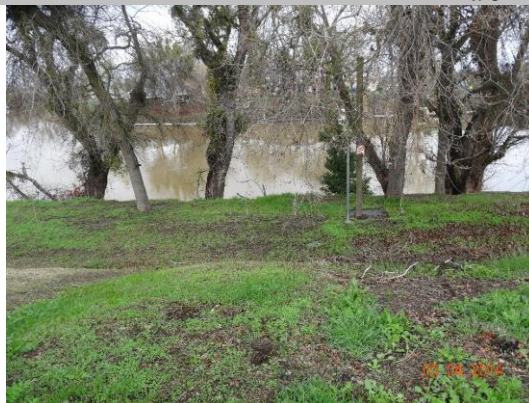
Photo 3 of 3 : UCIP_SP_2019_45403_60803.jpg

Comment Code						
Inspector Comment						
FS_ID:45403 DS_ID:19513 EP_NO: 9424 Repair Type: Non-Urgent Crossing Status: Indicator Found UCIP Comments: Unable to determine alignment of crossing--it's either through levee or along landward side. It appears that the waterline goes along landward side. Need to contact owner to obtain additional information about crossing. 2 inch metal pipe sticking out at the waterward berm edge. FIELD_STRUCT_DESC: Water pipe of an unknown size or material through the levee, at an unknown depth. Faucets on the landside (LS) slope. (Retention of an underground water pipe and faucet on the LS slope authorized under Automatic Board Order (ABO) issued as Permit No. 9424, 1974 - O. H. Ivey). [Additional Reference(s): DWR Levee Log, 2005]. FS Date: 3/4/2014

View of waterward side.

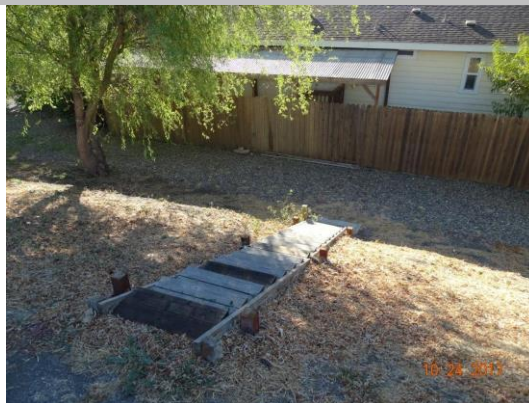
Photo 1 of 1 : SP_2019_NA0022_350_61_20190304_00033.jpg

View of stairs on landside slope. Fall 2017.

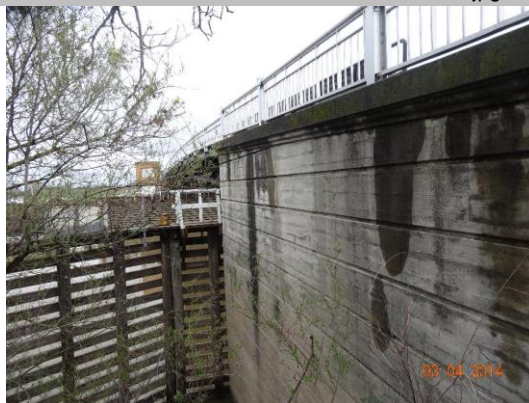
Photo 2 of 2 : UCIP_SP_2019_31906_58237.jpg

Comment Code					
Inspector Comment					
FS_ID:31906 DS_ID:19534 EP_NO: 17016 Repair Type: Non-Urgent Crossing Status: Indicator Found UCIP Comments: Unable to confirm crossing alignment--steel pipe visible on waterward side however, unable to confirm if crossing is the same one found during field confirmation. Need to contact owner to verify alignment and status of crossing. Slope was too steep to verify and obtain additional information about pipe. FIELD_STRUCT_DESC: Three 2-inch and three 1.5-inch fiber optics conduits through the levee, encased in a single high-density polyethylene (HDPE) casing, 30 feet below the crown. Concrete cap on each end of the HDPE casing. Voids in the HDPE casing grouted. (Plans to install three 2-inch and three 1.5-inch fiber optics conduits within a casing across and bored under the Sacramento River and its levees authorized under Permit No. 17016, 2000 - Worldwide Fiber). FS Date: 3/4/2014

No pipe attached along bridge.

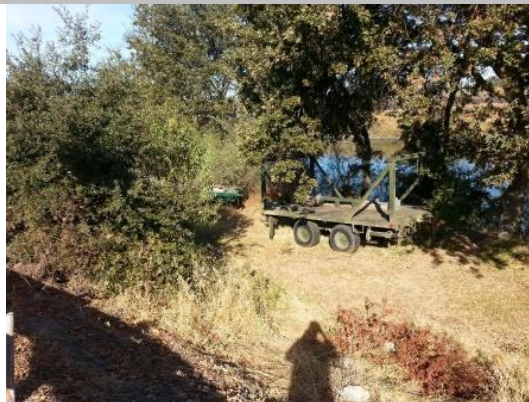
Photo 1 of 1 : SP_2019_NA0022_350_71_20190304_00035.jpg

Vehicles and equipment on waterward side of the levee. Fall inspection 10/07/2016.

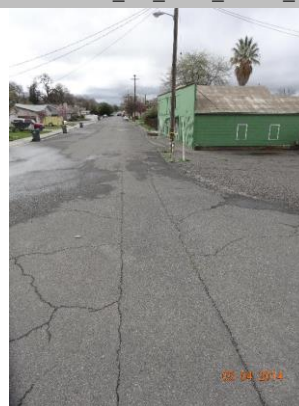
Photo 1 of 3 : UCIP_SP_2019_31627_57881.jpg

LM Start	0.51	Rating **	M	Issue No.	400
LM End	0.51	Issue Type +	En	Location *	
Category	Supplemental			GPS Latitude/Longitude	
				Start	End
Item	DWR UCIP Field Study			38.802062 °	38.802062 °
				-121.716740 °	-121.716740 °
DWR ID	19544				
Comment Code					
Inspector Comment					
FS_ID:31627 DS_ID:19544 EP_NO: N/A Repair Type: Non-Urgent Crossing Status: Indicator Found UCIP Comments: Unable to confirm if signs of crossing are for the same crossing listed here. Need to contact owner and determine additional information about crossing. Also found is service box for water line--need permit and alignment confirmation. FIELD_STRUCT_DESC: 10-inch steel pipe of an unknown purpose through the levee, at an unknown depth. [Additional Reference(s): DWR Levee Log, 2005. USACE Sacramento O&M Manual 127, June 1953, (Station 285+27)]. FS Date: 3/4/2014

View of landward side. Alignment is visible on paved road.

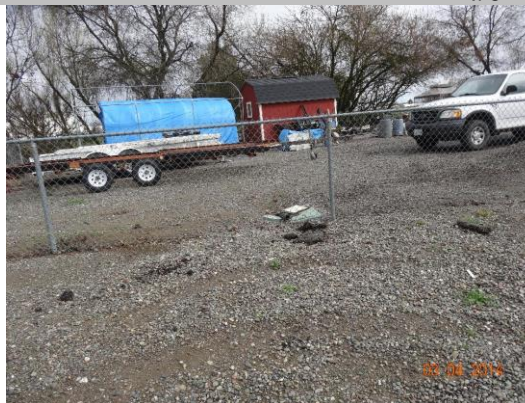
Photo 3 of 3 : UCIP_SP_2019_31627_57879.jpg

LM Start	0.51	Rating **	M	Issue No.	400 (cont)
LM End	0.51	Issue Type +	En	Location *	
Category	Supplemental			GPS Latitude/Longitude	
				Start	End
Item	DWR UCIP Field Study			38.802062 °	38.802062 °
				-121.716740 °	-121.716740 °
DWR ID	19544				
Comment Code					
Inspector Comment					
FS_ID:31627 DS_ID:19544 EP_NO: N/A Repair Type: Non-Urgent Crossing Status: Indicator Found UCIP Comments: Unable to confirm if signs of crossing are for the same crossing listed here. Need to contact owner and determine additional information about crossing. Also found is service box for water line--need permit and alignment confirmation. FIELD_STRUCT_DESC: 10-inch steel pipe of an unknown purpose through the levee, at an unknown depth. [Additional Reference(s): DWR Levee Log, 2005. USACE Sacramento O&M Manual 127, June 1953, (Station 285+27)]. FS Date: 3/4/2014

Service box located on waterward side near fence post.

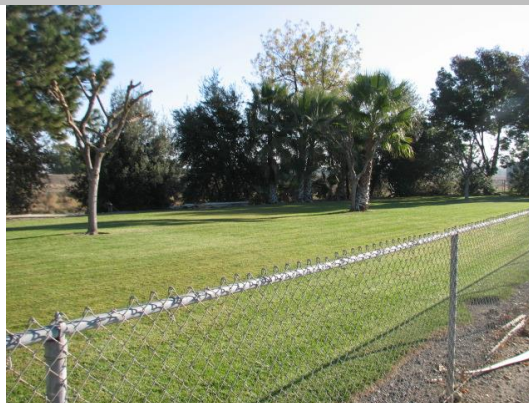
Photo 1 of 1 : SP_2019_NA0022_350_24_20190304_00011.jpg

LM Start	0.52	Rating **	U	Issue No.	63
LM End	0.53	Issue Type +	En	Location *	LS
Category	Earthen Levee			GPS Latitude/Longitude	
				Start	End
Item	Encroachments			38.801980 °	38.801929 °
				-121.716502 °	-121.716330 °
DWR ID	DWR_NA0022_01_f_2017_63				
Comment Code					
FE : Fence					
Inspector Comment

View of chain link fence on crown. Fall 2013.

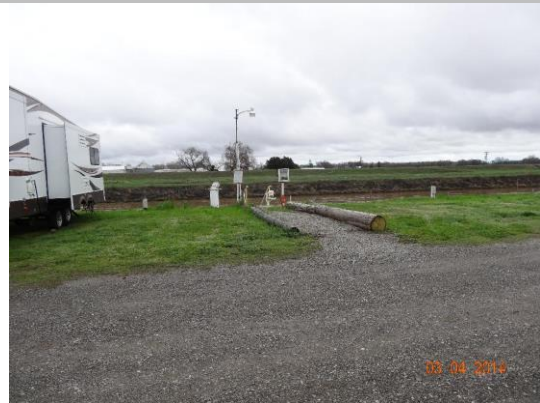
Photo 1 of 3 : UCIP_SP_2019_38188_69562.jpg

Comment Code					
Inspector Comment					
FS_ID:38188					
DS_ID:19519					
EP_NO: N/A					
Repair Type: Non-Urgent					
Crossing Status: Indicator Found					
UCIP Comments: Unable to find any signs of crossing on waterward side. Signs of concrete riser visible on landward side. If crossing is abandoned owner will need to coordinate with the Central Valley Flood Protection Board (CVFPB) for Title 23 requirements.					
FIELD_STRUCT_DESC: 10-inch pipe of an unknown material or purpose through the levee, 3.3 feet below the crown. 24-inch concrete riser on the landside (LS). Plate welded on the waterside (WS) end in 1975. [Additional Reference(s): DWR Levee Log, 2005].					
FS Date: 3/4/2014

View of waterward side.

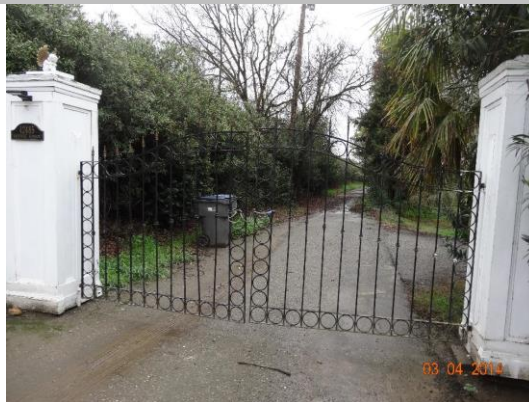
Photo 3 of 3 : UCIP_SP_2019_38188_69561.jpg

Comment Code					
Inspector Comment					
FS_ID:38188 DS_ID:19519 EP_NO: N/A Repair Type: Non-Urgent Crossing Status: Indicator Found UCIP Comments: Unable to find any signs of crossing on waterward side. Signs of concrete riser visible on landward side. If crossing is abandoned owner will need to coordinate with the Central Valley Flood Protection Board (CVFPB) for Title 23 requirements. FIELD_STRUCT_DESC: 10-inch pipe of an unknown material or purpose through the levee, 3.3 feet below the crown. 24-inch concrete riser on the landside (LS). Plate welded on the waterside (WS) end in 1975. [Additional Reference(s): DWR Levee Log, 2005]. FS Date: 3/4/2014

Residential property standpipe located behind fence.

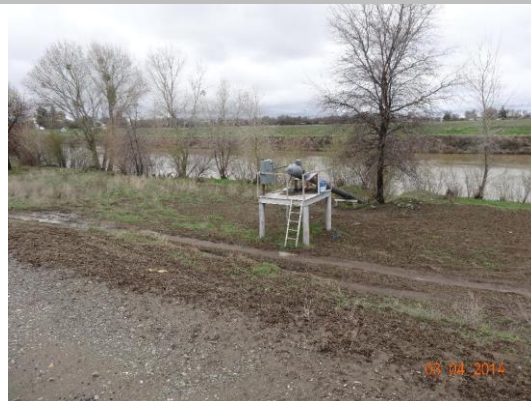
Photo 1 of 3 : UCIP_SP_2019_31969_58410.jpg

Comment Code						
Inspector Comment						
FS_ID:31969 DS_ID:19540 EP_NO: N/A Repair Type: Non-Urgent Crossing Status: Found UCIP Comments: Pipe section on waterward side appears to have been removed and reinstalled--Need to contact owner to obtain additional information regarding work completed. FIELD_STRUCT_DESC: 14-inch steel irrigation discharge pipe through the levee, 4.6 feet below the crown. Pump and valve on the riverbank. See DS_ID 19521. (Plans for installation of an angle mount low-lift pump and structure to replace an existing portable pumping plant, which will be connected to the existing 14-inch discharge pipe through the levee authorized under Permit No. 3798, 1961 - Alta Morris). [Additional Reference(s): USACE Sacramento O&M Manual 127, June 1953, (Station 266+72.2)]. FS Date: 3/4/2014

View of waterward side.

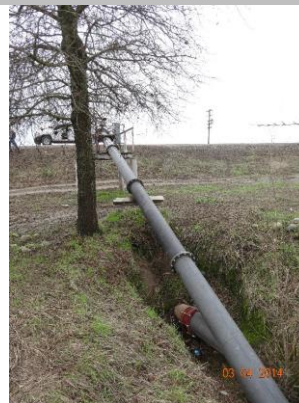
Photo 2 of 3 : UCIP_SP_2019_31969_58409.jpg

Comment Code						
Inspector Comment						
FS_ID:31969						
DS_ID:19540						
EP_NO: N/A						
Repair Type: Non-Urgent						
Crossing Status: Found						
UCIP Comments: Pipe section on waterward side appears to have been removed and reinstalled--Need to contact owner to obtain additional information regarding work completed.						
FIELD_STRUCT_DESC: 14-inch steel irrigation discharge pipe through the levee, 4.6 feet below the crown. Pump and valve on the riverbank. See DS_ID 19521. (Plans for installation of an angle mount low-lift pump and structure to replace an existing portable pumping plant, which will be connected to the existing 14-inch discharge pipe through the levee authorized under Permit No. 3798, 1961 - Alta Morris).						
[Additional Reference(s): USACE Sacramento O&M Manual 127, June 1953, (Station 266+72.2)].						
FS Date: 3/4/2014

Pipe located on waterward side.

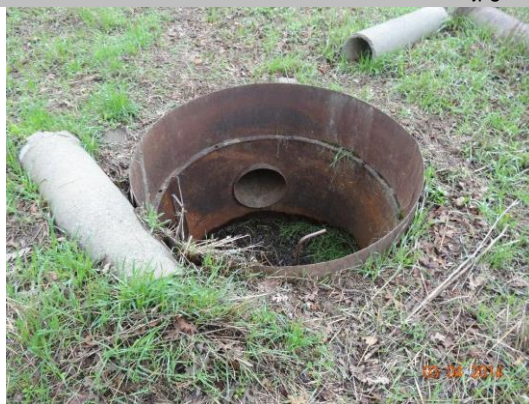
Photo 2 of 3 : UCIP_SP_2019_31912_58260.jpg

Comment Code						
Inspector Comment						
FS_ID:31912 DS_ID:19522 EP_NO: 6296 Repair Type: Non-Urgent Crossing Status: Found UCIP Comments: Siphon breaker housing on landward slope unit damaged and debris scattered on landward side. Unable to determine if crossing is still in use. Need to contact owner to determine status of crossing. FIELD_STRUCT_DESC: 12-inch (not 14-inch as indicated in the desk study) coated steel irrigation discharge pipe through the levee, 11.8 feet below the crown. Standard corrugated metal cutoff wall around pipe at centerline of levee. 1.25-inch electrical conduit through the levee. Electrical control panel on the waterside (WS) slope. Slant pump mounted on a steel structure on the riverbank. Siphon breaker on the landside (LS) shoulder. Pipe extends from pump to existing irrigation ditch at the LS toe. (Plans to install a pump and pipe through the levee authorized under Permit No. 6296, 1968 - Emma Collier). [Additional Reference(s): DWR Levee Log, 2005]. FS Date: 3/4/2014

Riser on landward toe.

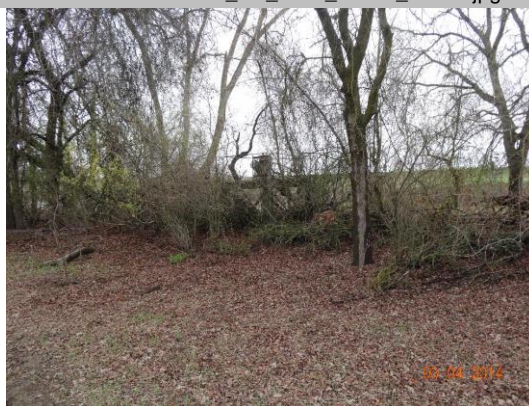
Photo 3 of 3 : UCIP_SP_2019_31912_58259.jpg

Comment Code						
Inspector Comment						
FS_ID:31912 DS_ID:19522 EP_NO: 6296 Repair Type: Non-Urgent Crossing Status: Found UCIP Comments: Siphon breaker housing on landward slope unit damaged and debris scattered on landward side. Unable to determine if crossing is still in use. Need to contact owner to determine status of crossing. FIELD_STRUCT_DESC: 12-inch (not 14-inch as indicated in the desk study) coated steel irrigation discharge pipe through the levee, 11.8 feet below the crown. Standard corrugated metal cutoff wall around pipe at centerline of levee. 1.25-inch electrical conduit through the levee. Electrical control panel on the waterside (WS) slope. Slant pump mounted on a steel structure on the riverbank. Siphon breaker on the landside (LS) shoulder. Pipe extends from pump to existing irrigation ditch at the LS toe. (Plans to install a pump and pipe through the levee authorized under Permit No. 6296, 1968 - Emma Collier). [Additional Reference(s): DWR Levee Log, 2005]. FS Date: 3/4/2014

View of waterward side.

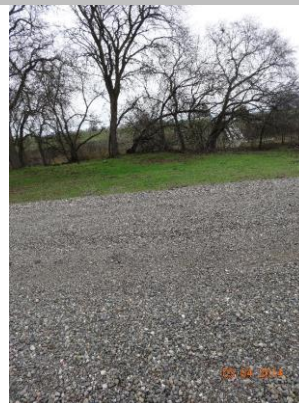
Photo 1 of 3 : UCIP_SP_2019_38190_69563.jpg

LM Start	1.75	Rating **	M	Issue No.	405
LM End	1.75	Issue Type +	En	Location *	
Category	Supplemental			GPS Latitude/Longitude	
				Start	End
Item	DWR UCIP Field Study			38.797928 °	38.797928 °
				-121.697992 °	-121.697992 °
DWR ID	19539				
Comment Code					
Inspector Comment					
FS_ID:38190 DS_ID:19539 EP_NO: N/A Repair Type: Non-Urgent Crossing Status: Indicator Found UCIP Comments: Need to contact owner to determine status of crossing. FIELD_STRUCT_DESC: *ABANDONED* 12-inch corrugated metal irrigation discharge pipe through the levee, at an unknown depth. Gate valve in pump house on the waterside (WS), no pump house found. Crossing was abandoned prior to 1968. [Additional Reference(s): USACE Sacramento O&M Manual 127, June 1953, (Station 224+3.5), 18-inch pipe referenced]. FS Date: 3/4/2014

View of waterward side.

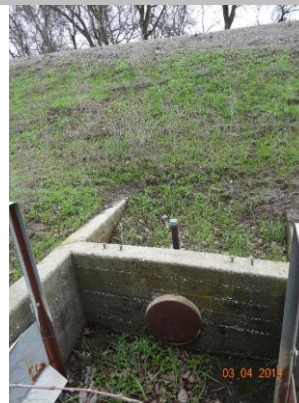
Photo 3 of 3 : UCIP_SP_2019_38190_69564.jpg

Concrete box located on landward toe.

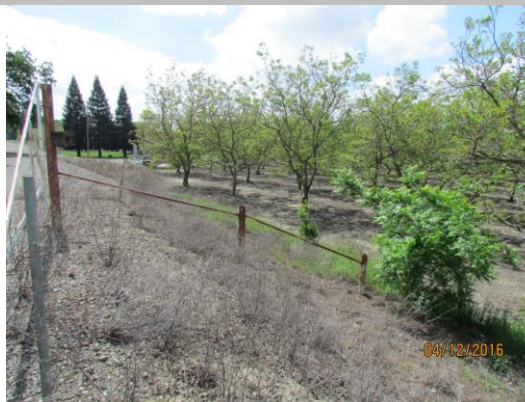
Photo 1 of 1 : SP_2019_NA0022_350_112_20190304_00052.jpg

View of the tree at the toe of the levee on the landward side looking downstream. Spring 2016.

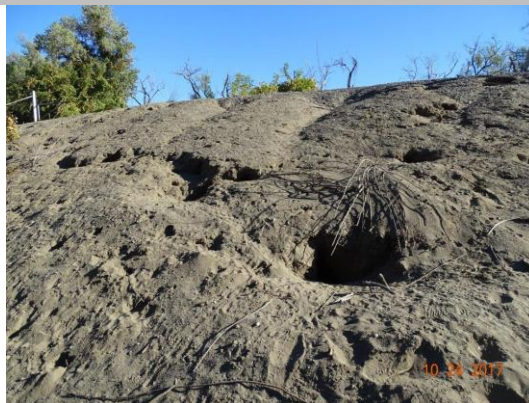
Photo 2 of 2 : SP_2019_NA0022_350_8_20190304_00004.jpg

View of rodent holes on landside slope. Fall 2017.

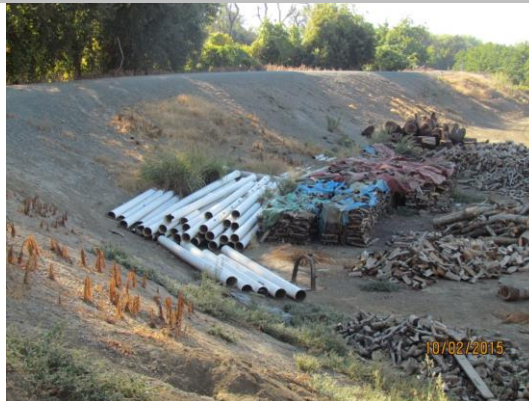
Photo 2 of 2 : SP_2019_NA0022_350_40_20190304_00022.jpg

View of equipment on the landward side of the levee looking downstream. Fall 2015.

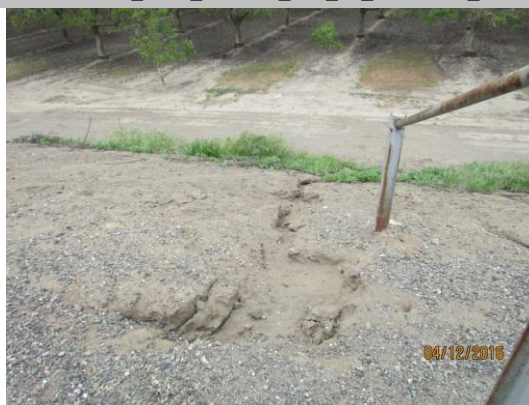
Photo 1 of 2 : SP_2019_NA0022_350_35_20190304_00015.jpg

Erosion is on the landward side of the levee. Spring 2016.

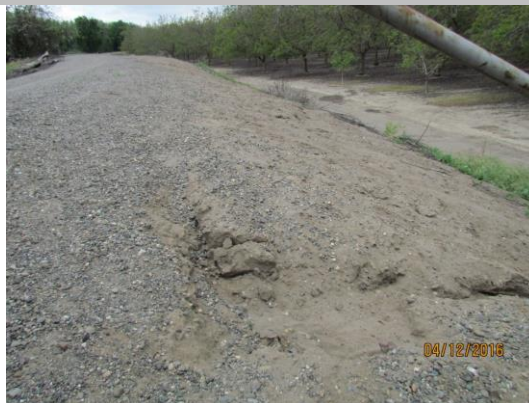
Photo 2 of 2 : SP_2019_NA0022_350_35_20190304_00016.jpg

Perspective view of the erosion on the landward side of the levee. Spring 2016.

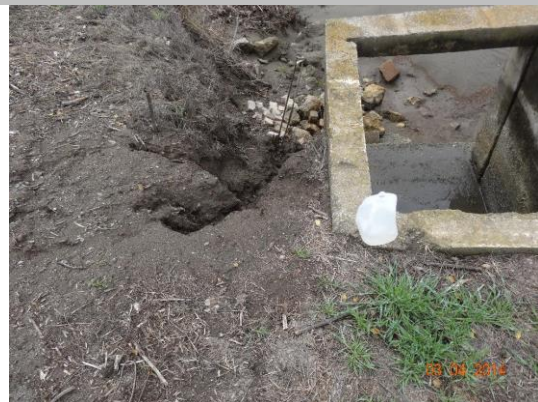
Photo 2 of 3 : UCIP_SP_2019_52726_57914.jpg

Slope erosion near concrete box.

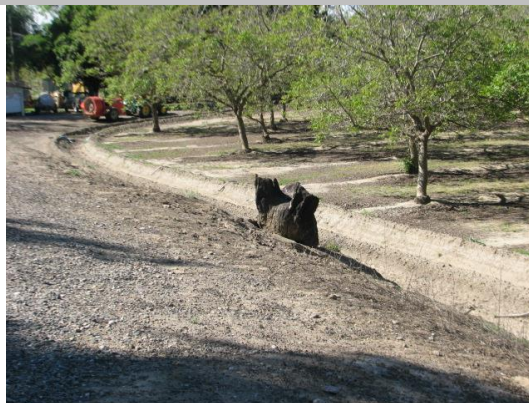
Photo 1 of 1 : SP_2019_NA0022_350_37_20190304_00019.jpg

Tree stump decomposing and may pose a risk to the levee. Spring 2014

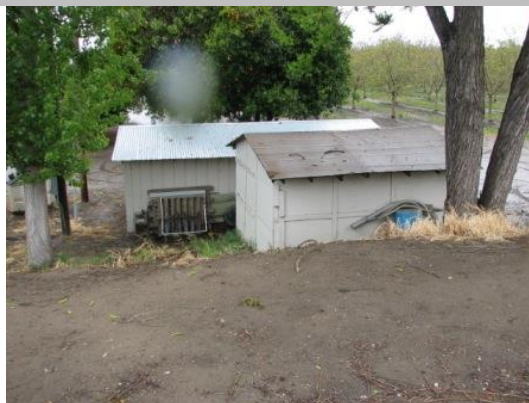
Photo 1 of 1 : SP_2019_NA0022_350_11_20190304_00005.jpg

Garage at toe.

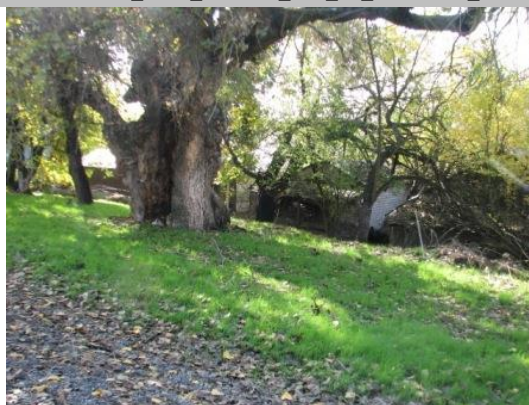
Photo 1 of 2 : SP_2019_NA0022_350_12_20190304_00006.jpg

Buildings are located at the toe of the levee. Fall 2012

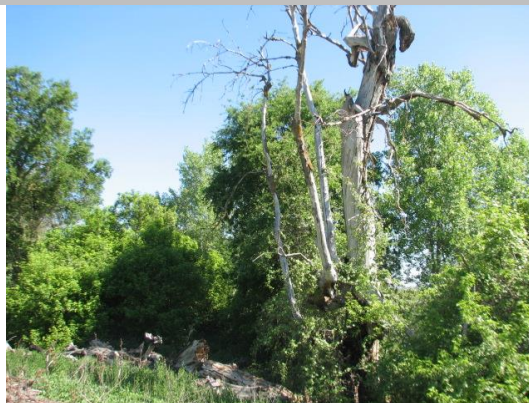
Photo 1 of 2 : SP_2019_NA0022_350_47_20190304_00026.jpg

Some trees have fallen and others are dying and need to be monitored.
The trees may pose a threat to the levee. Spring 2014

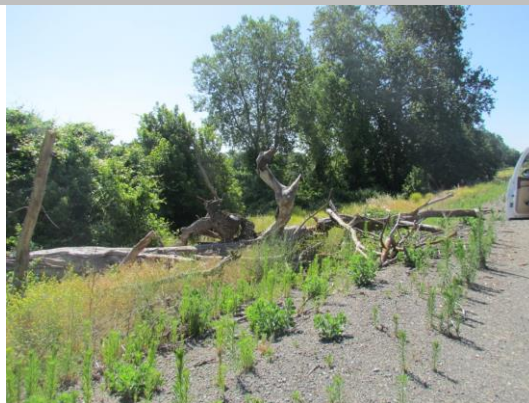
Photo 2 of 2 : SP_2019_NA0022_350_47_20190304_00027.jpg

View of the fallen tree on the waterward side of the levee looking downstream. Spring 2015.

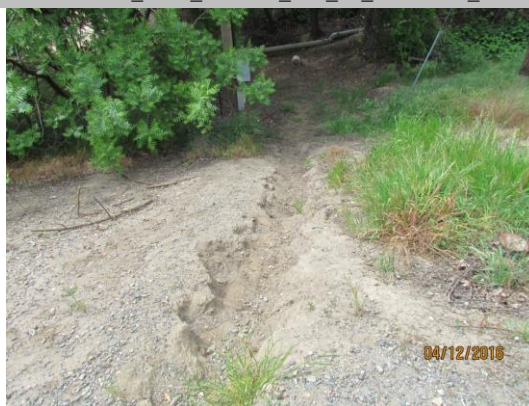
Photo 2 of 3 : SP_2019_NA0022_350_79_20190304_00037.jpg

View of erosion on the landside slope. Spring 2016.

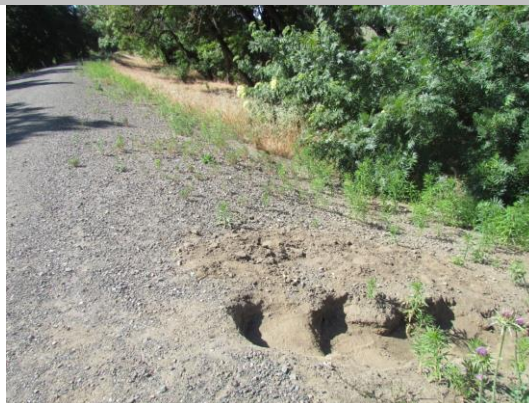
Photo 3 of 3 : SP_2019_NA0022_350_79_20190304_00036.jpg

View of the stairs on the landward side of the levee looking downstream. Spring 2015.

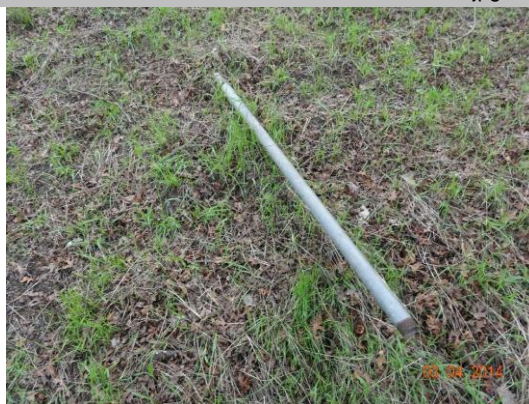
Photo 3 of 3 : UCIP_SP_2019_38996_69566.jpg

Abandoned conduit line through levee.

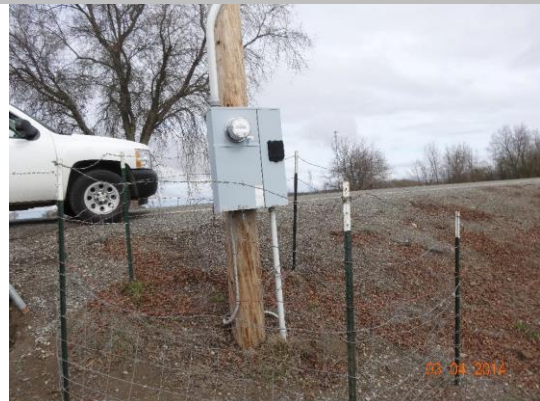
Photo 2 of 3 : UCIP_SP_2019_52728_69572.jpg

Power pole with conduit line through levee.

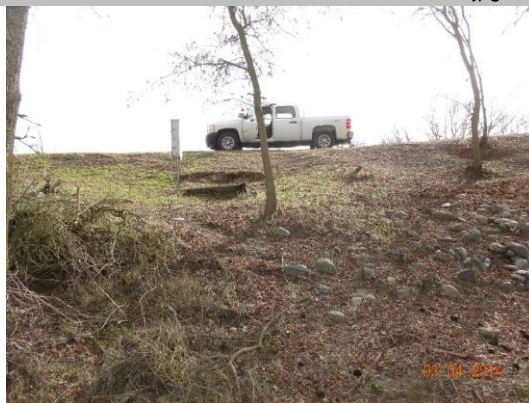
Photo 2 of 3 : UCIP_SP_2019_31927_58331.jpg

Rip rap along waterward slope.

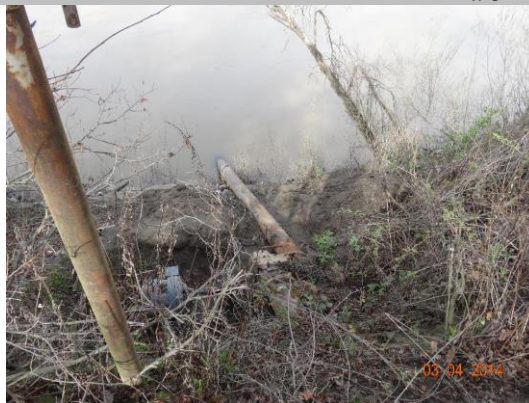
Photo 3 of 3 : UCIP_SP_2019_31927_58335.jpg

Pipe visible on waterward toe.

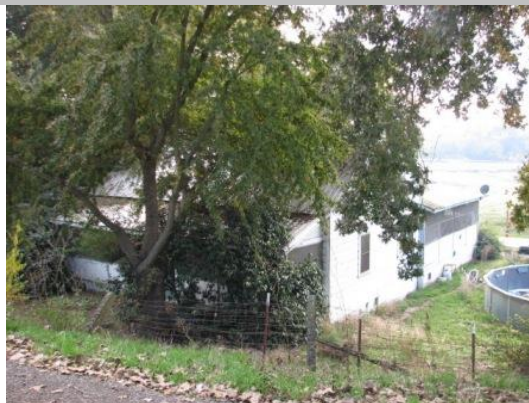
Photo 1 of 1 : SP_2019_NA0022_350_1_20190304_00001.jpg

The house and landscape are in the easment of the levee. Fall 2011

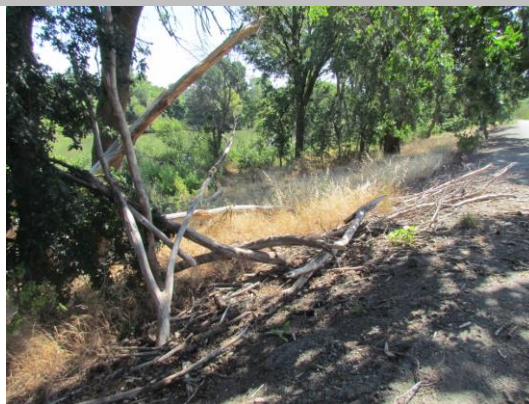
Photo 1 of 1 : SP_2019_NA0022_350_83_20190304_00040.jpg

View of the tree and tree limbs on the waterward side of the levee looking downstream. Spring 2015.

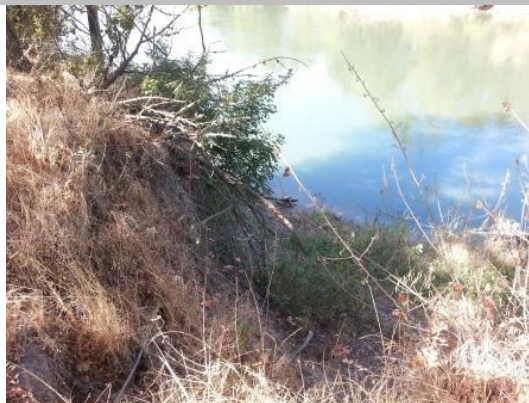
Photo 1 of 3 : SP_2019_NA0022_350_84_20190304_00041.jpg

View of an erosion site on waterward slope. Fall inspection 10/07/2016.
